TOWARDS TRAJECTORIES OF INCLUSION, MAKING INFRASTRUCTURE WORK FOR THE MOST MARGINALISED 2020/2023

TECHNICAL PROPOSAL FOR THE COMMUNITY INTERVENTION

TECHNICAL PROPOSAL FOR THE COMMUNITY INTERVENTION - WATER SUPPLY IMPROVEMENT IN SARNIA ESTATE, BADULLA

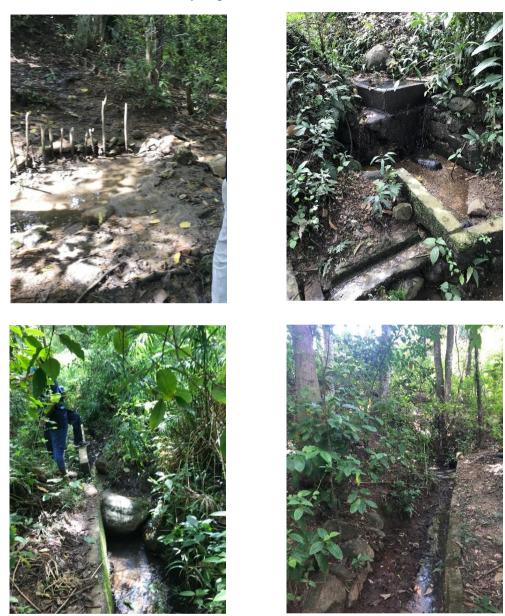
Figure 3: Main Water Source- Water Spring, Filter Chamber and Drains

The main source of the water supply for these settlements is through natural springs located at higher elevation in the Mahatenna area. Three (3) earth drains were built on the catchment area to collect water as the main components of this spring water source. Out of these drains, only two consist of masonry side walls about 2 feet high (one side only) to collect water for the filter chamber. The water collected in these drains from springs in the catchment area is diverted into the water storage tank through the filter chamber as shown in below figures.

The distribution lines that are laid from this storage tank (which was built about 15 years ago) directly supplies water for ADB Quarters, Ottu Line, and Mettu Line, which is irregular and frequently interrupted. This storage tank is not functioning properly, and no water is stored there due to an improper way of fixing the distribution lines without any control valves.

- Investigating the existing water distribution system in the area, it was observed that there is a complication in the pattern of the existing water network (Please refer to Annexure 01). The intake area is not protected and is filled with leaves and other debris.

- A filter chamber was constructed, which is not maintained properly, and therefore water flows through it to the storage tank. However, due to several pipe lines connected to the bottom of the storage tank, the water does not get stored in the tank and instead flows through many pipe lines. There are some leaks through the bottom of the existing masonry side walls of the intake drains. As a result of these leakages, the retaining capacity of water in the intake area is reducing.

- The filter chamber is filled with earth, and washouts are blocked and not protected (no cover slab). Water from the filter chamber flows to the storage tank through an open channel that is also not protected.

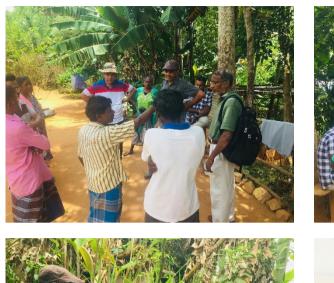
Figure 10: Community views on the existing water supply system

The residents are not satisfied with the existing water supply system since it is not regular or sufficient to meet their daily water needs. They also expressed that there is no proper water supply and management system in operation at present. The current practice is ad-hoc and unreliable. Therefore, they are not satisfied.

All the community members have pointed out that the Mahathenna water source has sufficient water capacity if it is properly protected and stored. Further, they have mentioned the possibility of constructing deep wells and pumping water to storage tanks to distribute to the families.

They have no idea about the technical options for water supply but have emphasized the need for a properly managed water supply system under the close supervision of the estate management.

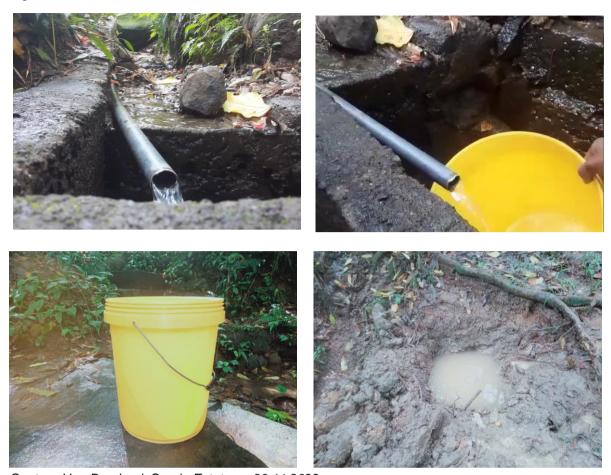
Figure 11: Yield Test at Mahatenna Water Source

SEVANATHA with the support of community facilitator in Mahatenna has carried out a water yield test of Mahatenna source on 30th November 2022 and the results of test are given below:

After conducting the water yield test, the technical expert has suggested to consider that test point at filter chamber to be considered being the most appropriate point of the yield test, the result of which would be used for estimation of the volume of water generated in the catchment. Further, it is expected that with the improvement of the water catchment, the volume of water yield would be improved as indicated in the below table.

According to the above analysis, with 10% improvement of water yield from the present source and after allowing for 10% lose, the daily minimum water needs of target beneficiary families could be achieved (23,540 liters per day).

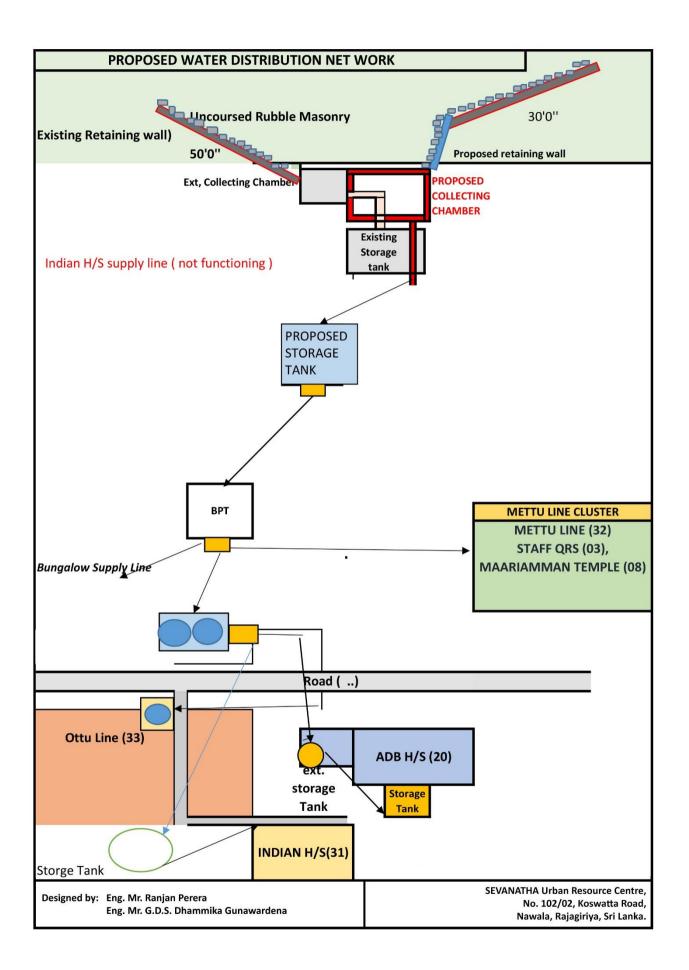
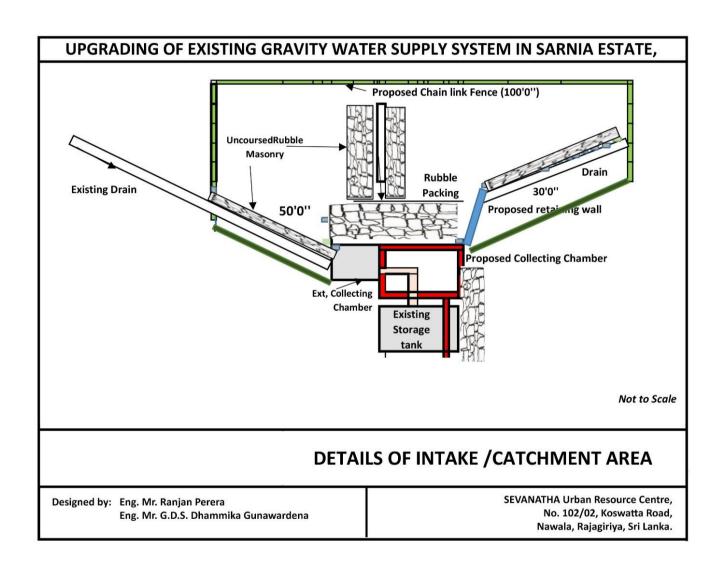
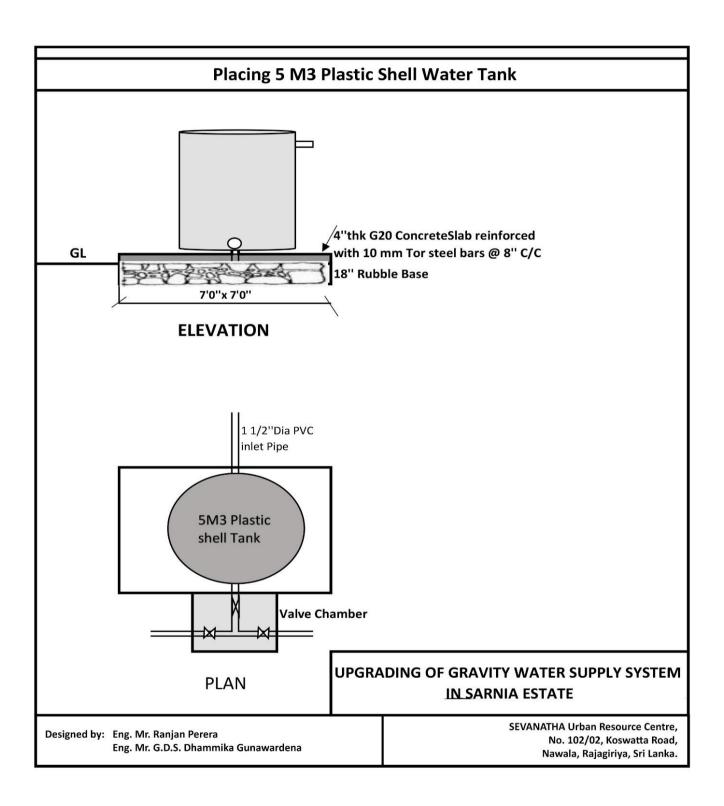
Annexure 01: Diagrams of the Proposed Community Interventio	n

The updated design of the intake, filter tank and the water distribution network are included in Annexure 01.
